Thank you for your interest in the Avnet MicroZed System-On-Modules. Although Avnet has made every effort to ensure the highest possible quality, these kits and associated software are subject to the limitations described in this errata notification.

2 Identifying Affected Modules

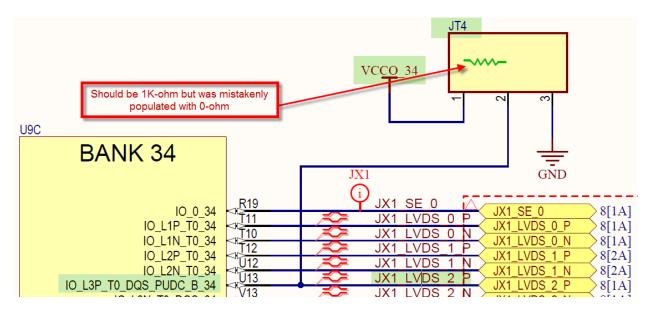
Figure 2 – JT4 Pull-up Connected to PUDC_B, JX1_LVDS_2_P, and JX1-Pin17

PUDC_B is a signal on the Zynq-7000 device that stands for "Pull-Ups During Configuration," and it is active low. Since pull-ups during configuration can adversely affect I/Os that are strapped low, Avnet typically disables PUDC by adding a pull-up to the PUDC_B signal.

On MicroZed, the PUDC_B signal is in Bank 34 of the Zynq-7000, Pin U13 on component U9C on Sheet 6 of the schematic document. This pin is tied to schematic signal JX1_LVDS_2_P, which is also tied to resistor jumper JT4 and Micro Header JX1 Pin 17.

Resistor jumper JT4 is a 3-pad component that allows an 0402 resistor to be placed either in the 1-2 position or the 2-3 position. By default, this was supposed to be populated with a 1K-ohm resistor in the 1-2 position. Unfortunately, this was mistakenly populated with a 0-ohm resistor, thus shorting JX1_LVDS_2_P to power supply VCCO_34. This effectively disables PUDC, but it also makes this I/O unusable.

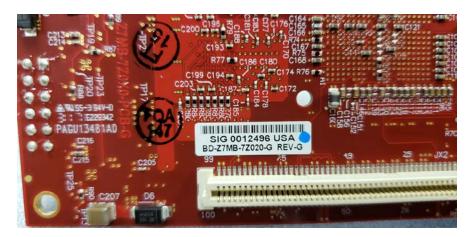
Figure 4 - Repaired MicroZed Rev G Board

A repaired Revision G board that has this workaround in place will be identified with a blue mark on the bar code label as shown below:

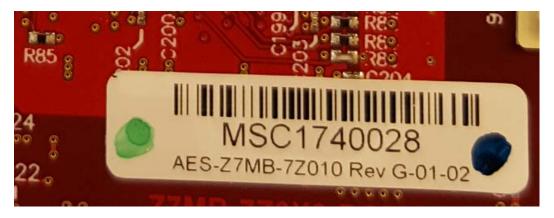
Figure 6 - Repaired MicroZed Rev G Board

LED D3 was placed backwards during assembly and will therefore not operate properly. Once the LED is soldered in reverse position, it will operate correctly.

A repaired Revision G board that has this workaround in place will be identified with a green mark on the bar code label as shown below. See 3.1 for an explanation regarding the blue mark on the right side.

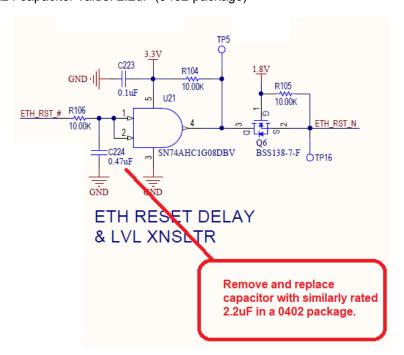
Figure 7 - Ethernet Reset Capacitor for Proper Delay

Resistor/Capacitor circuit R106/C224 of the MicroZed 7010/7020 is affected by this erratum. The resistor/capacitor values that are placed do not meet the Ethernet reset requirement of 10ms that is required by the PHY. The current time required to release the Ethernet reset is on the order of 4.7 milliseconds.

If the Ethernet reset duration significantly impacts operation in the end user application an option exist that will allow for proper operation of the Ethernet PHY. The option is to modify hardware to change the capacitor value of the resistor/capacitor combo that will allow for a time constant that is larger than the 10ms that is required by the PHY.

Recommended C224 capacitor value: 2.2uF (0402 package)

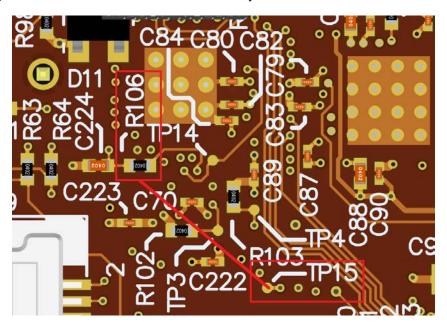
Figure 9 - Ethernet Reset Proper Voltage Level on MicroZed

Signal ETH_RST_# of the MicroZed 7010/7020 is affected by this erratum. This signal is the output of a translation circuit from 3.3V to 1.8V and enters the ethernet reset RC delay circuit described previously. The ETH_RST_# signal is the source for the RC time delay circuit used to implement the final ethernet reset to the PHY. The VIH (high-level input voltage) for the AND GATE IC, U21, that the delayed 1.8V ETH_RST_# signal drives has a minimum voltage of 2.1V which will not be achievable by the ETH_RST_# signal. This circuit relies on the 3.3V output pullup to bring the signal to a safe 3.3V level prior to being translated to 1.8V by the FET circuit prior to the PHY.

If the Ethernet reset control impacts operation in the end user application a possible option exists that will allow for proper operation of the Ethernet PHY. The option is to modify hardware to dead bug resistor R106 to remove ETH_RST_# from the RC time delay circuit. Where the dead bug of resistor R106 occurs, signal PG_MODULE, TP15 in Figure 9 below, could be used to replace the ETH_RST_# signal which would put the proper voltage level on the ethernet reset RC time delay and translator circuits.

This workaround should not be anticipated as a permanent solution. It is recommended that users migrate to MicroZed Revision H to avoid this voltage level issue if proper operation of the Ethernet PHY is needed.

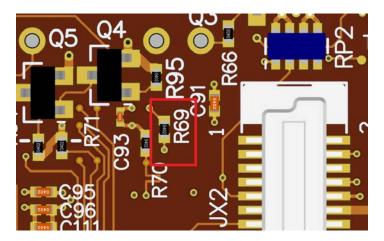
Figure 10 - QSPI Reset Resistor R69 on MicroZed

QSPI pin A4 is RST#/RFU and is currently attached through a 0-ohm resistor to signal PS_SRST#. The QSPI is operated from a 3.3V power supply and concerns have been raised that the PS_SRST# signal is a 1.8V signal.

Removing 0-ohm resistor R69 would allow the QSPI device to only use an internal pull-up resistor to control the reset of the device and eliminate the concern that a 1.8V signal was driving a 3.3V IO.

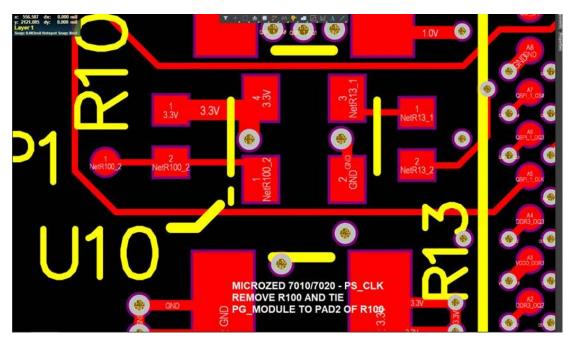
Figure 11 – OSC Enable Resistor R100 on MicroZed

Under certain conditions, during power-on and power-off the integrity of the Zynq-7000 SoC PS eFUSE settings can be affected. Xilinx produced Answer Record AR# 65240 which is a design advisory for Zynq-7000 SoC covering power on and power off sequencing requirements for eFuse Integrity. Xilinx also updated sequencing requirements in their Zynq-7000 datasheets covering power on and power off sequencing for the Zynq-7000 series of devices.

Specifically, MicroZed when operated in standalone mode fails the power off test number 4 which is a test to see if PS_POR_B is held de-asserted ($V_{\text{CCO_MIO0}}$) and the voltage ramp downs on V_{CCPINT} , V_{CCPAUX} and $V_{\text{CCO_MIO0}}$ are *monotonic* until at least one of the supplies reaches and stays below 0.40V, 0.70V and 0.90V respectively. During testing, in standalone mode, the MicroZed de-asserts and reasserts the PS_POR_B during power off and it has been shown that the PS_POR_B on reassertion occurs prior to some of the mentioned rails being below the presented levels. It has also been found that the PS_CLK signal is also still oscillating during this power off period.

If the eFuse integrity issues impacts module operation in standalone mode, possible modification options exist that will allow for proper operation resolving the issues potentially affecting eFuse integrity. The first modification is to tie PG_MODULE signal to the ENABLE pin of the PS_CLK oscillator. The second modification is to remove the TLV62130 power supplies on the module and replace with TLV62130A devices. The TLV62130A has a more robust Power Good signal which resolves the issues seen in standalone mode.

The modification to the PS_CLK oscillator is to tie PG_MODULE signal to PAD 2 of R100 (NETR100_2) in Figure 11.
