Thank you for your interest in the Avnet MicroZed System-On-Modules. Although Avnet has made every effort to ensure the highest possible quality, these kits and associated software are subject to the limitations described in this errata notification.

2 Identifying Affected Modules

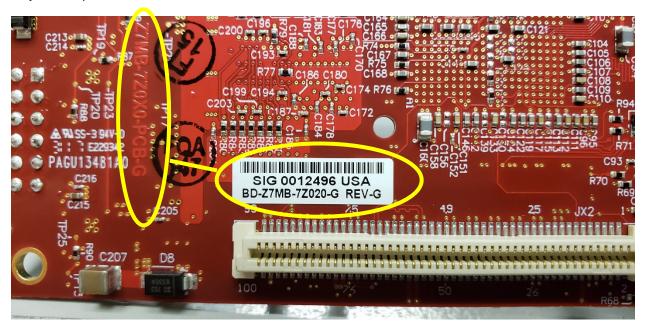
Figure 1 - Identifying MicroZed Revision G

The modules affected by these errata can be identified by the Revision of the MicroZed System-On-Module. The revision of the MicroZed System-On-Module can be found on the bottom side of the PCB board. The affected PCB boards are the MicroZed Revision G, identified as PCB assembly number "BD-Z7MB-Z7020-G REV-G" or "BD-Z7MB-Z7020I-G REV-G" or number "BD-Z7MB-Z7010I-G REV-G" with an embedded "PCB-G" also visible in the board etching.

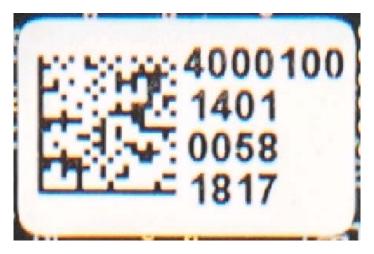
Figure 5 – Example 2D Bar Code for Future Rev G MicroZed Boards (Note: this is only an example bar code, not from MicroZed)

New Revision G boards with Revision Code G-03-03 or later will have a 2D bar code label like the one shown below. These boards do not have the issue.
