CASE STUDIES

Mestalla

Place: **Valencia, Spain**

Systems: **Aero, Artec & HQ Series**

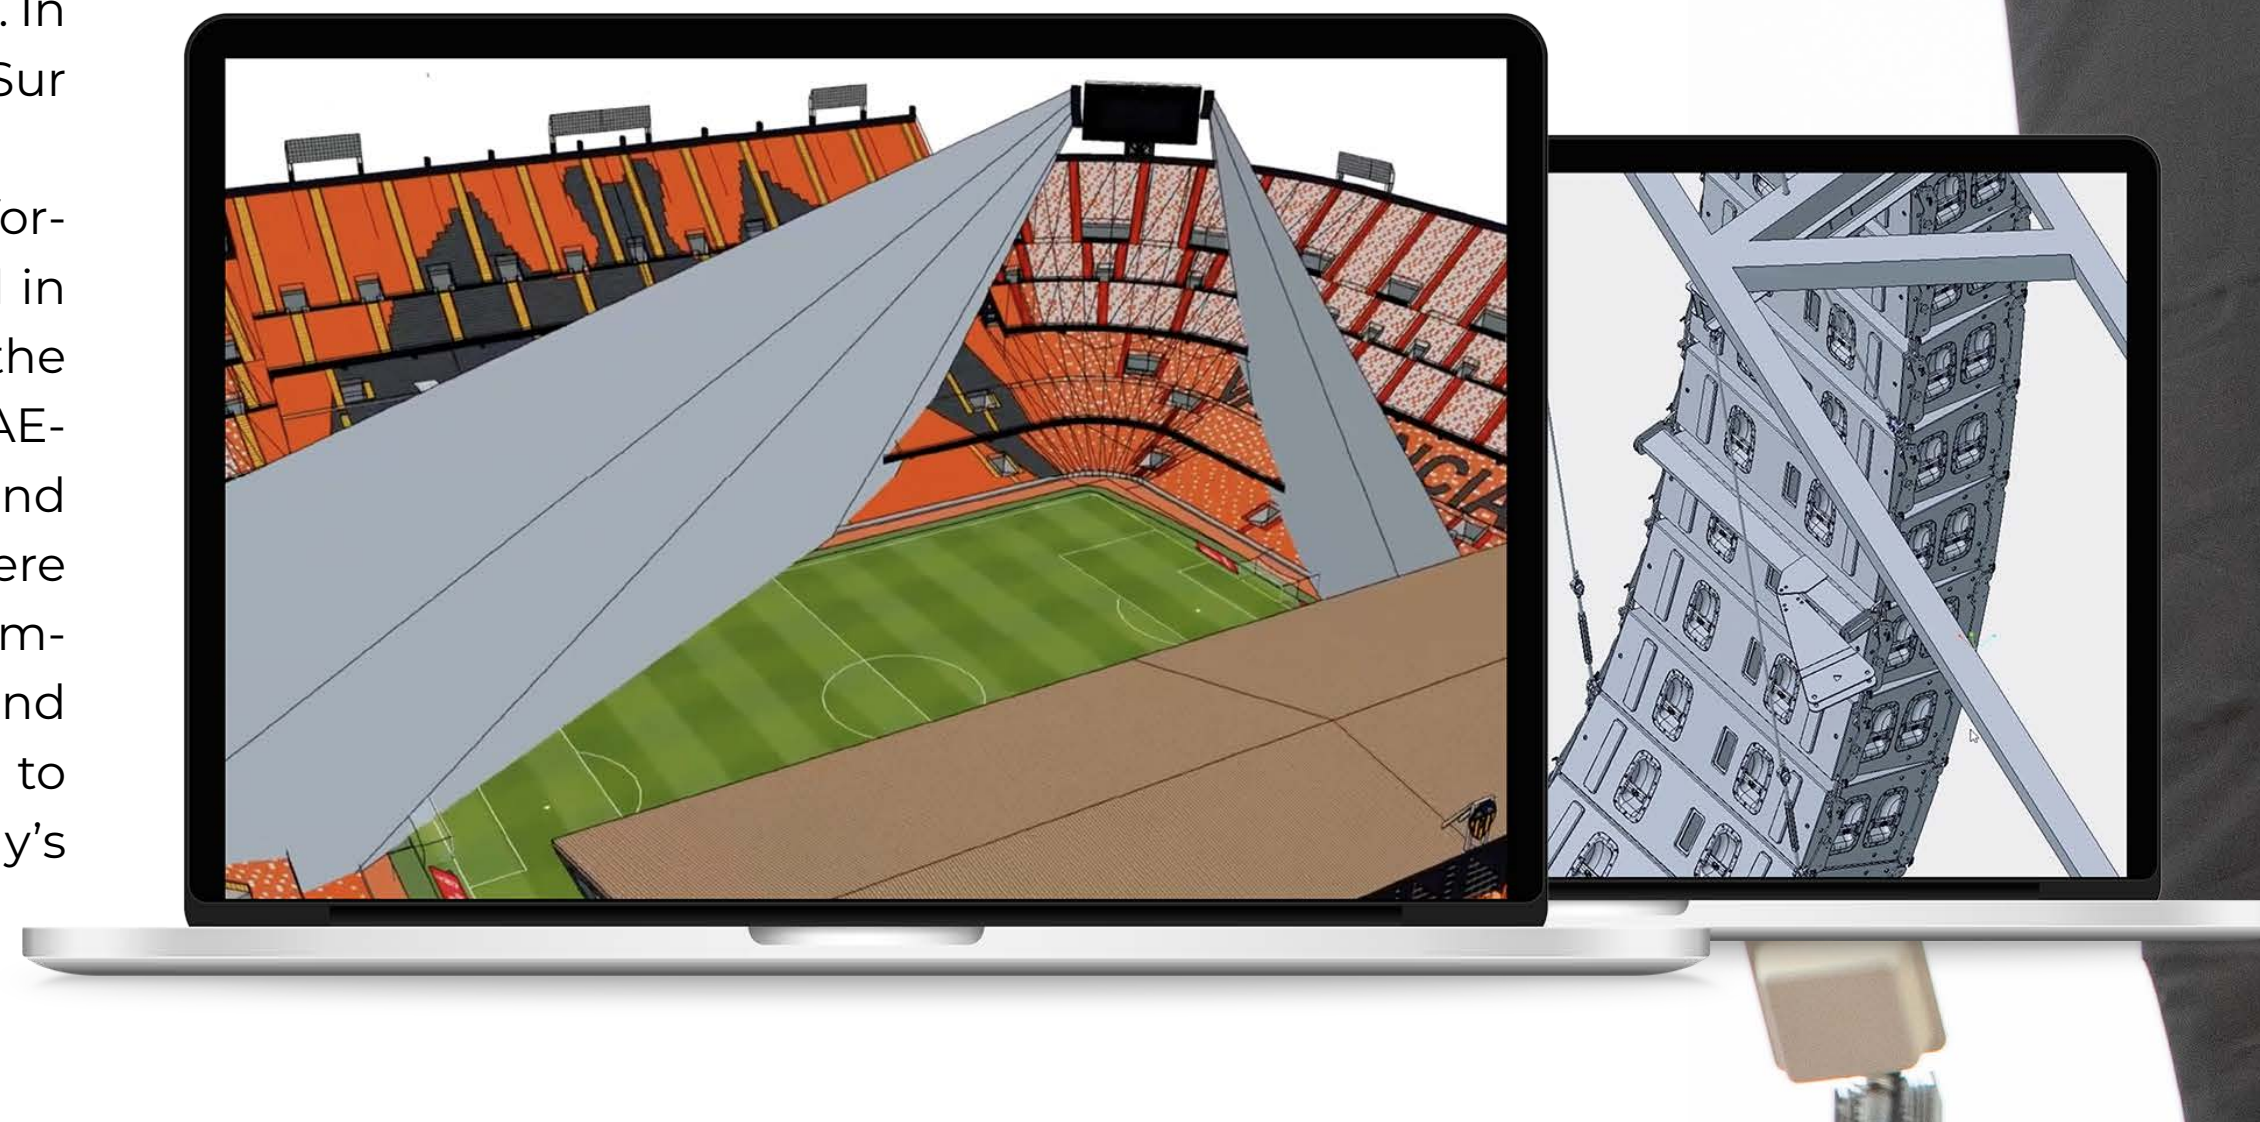
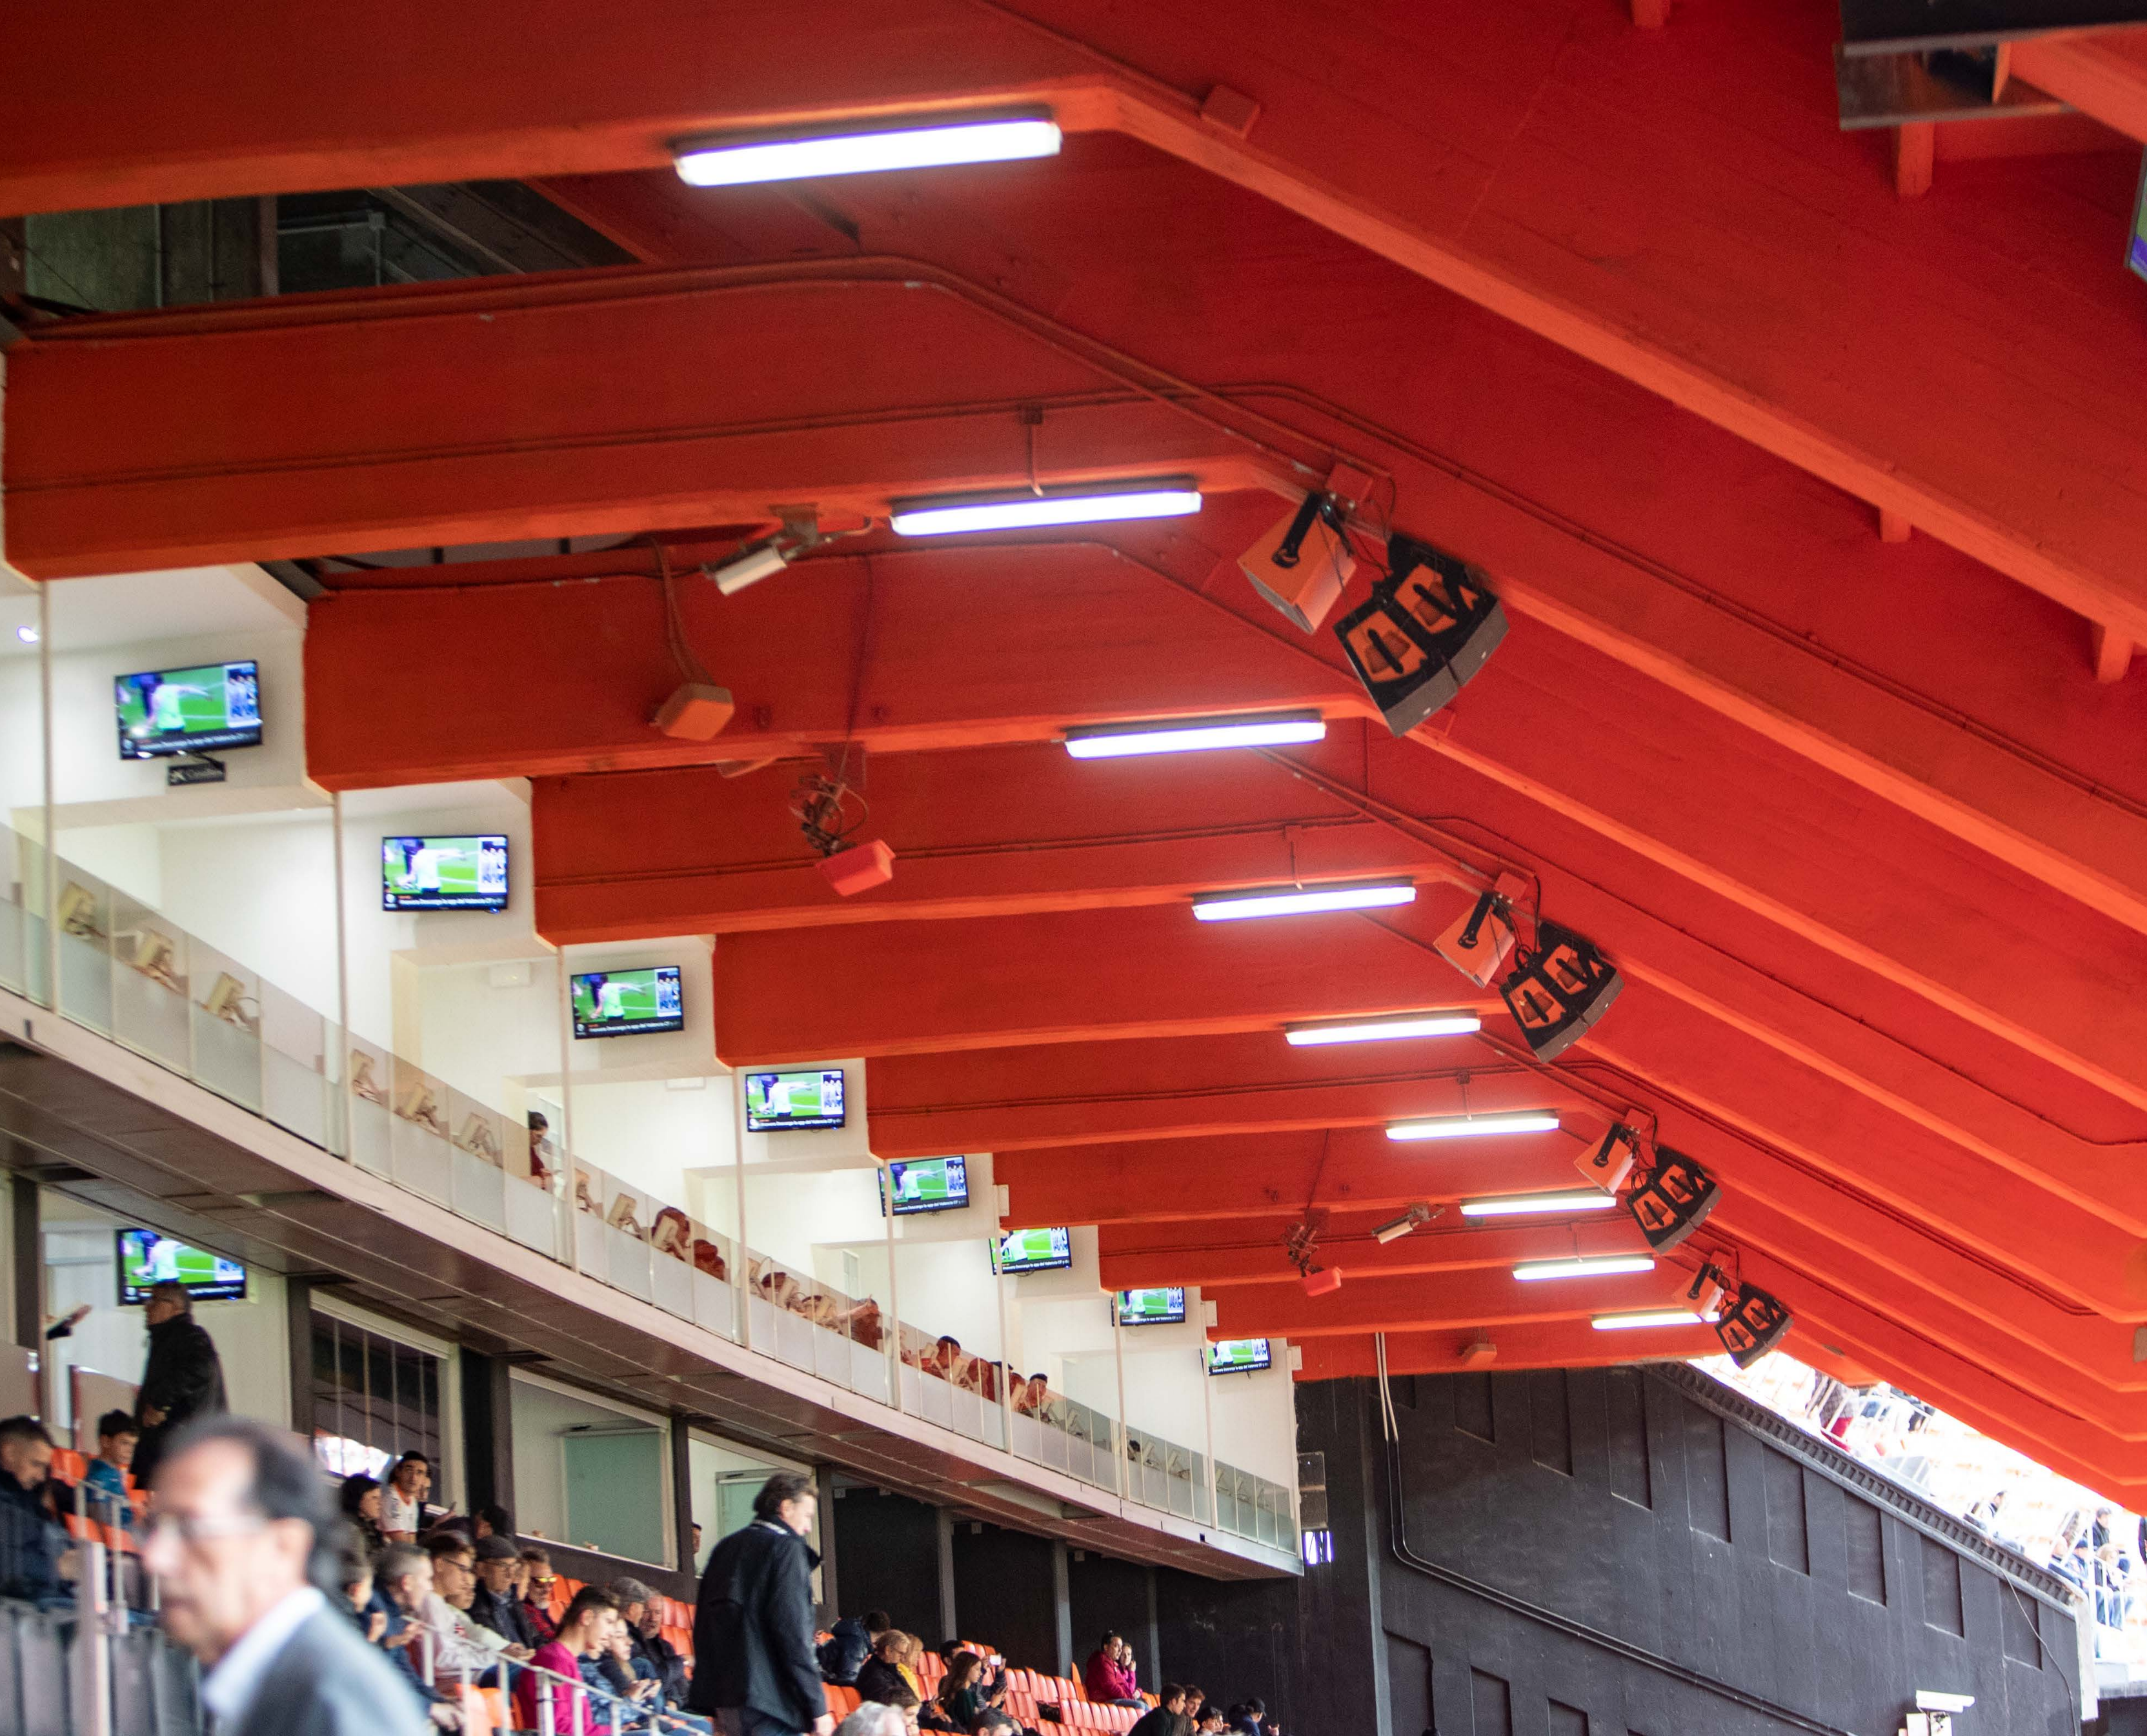
"One of the biggest challenges was the complexity of the system's location," said Álvaro Plumed, DAS Audio applications engineer, "so we opted for two strategically located line arrays with both vertical and horizontal angles that were precisely calculated to maximize the uniformity of energy distribution throughout the stadium. Consequently, four independent signal processors were used for the line array located to the left of the scoreboard and three for the line array to the right, which made it possible to homogenize the pressure levels throughout the stadium. We also added a central system above the scoreboard to provide coverage to the area below the scoreboard."

After an extensive acoustic study of the stadium, a line array system based on twenty-four AERO-50 modules was chosen and deployed in two systems strategically located on either side of the main electronic scoreboard to focus the power on the fans.
